Report No. TR 82-F-2

CHEM-BRAZE ABRADABLE SEAL ATTACHMENT TO AIRCRAFT GAS TURBINE COMPRESSOR COMPONENTS

S. T. NARSAVAGE, S. SAFAI, and H. W. PETTIT, Jr.
United Technologies Corp., Pratt & Whitney Aircraft Group
Government Products Division
P.O. Box 2691
West Palm Beach, Florida 33402

FINAL REPORT

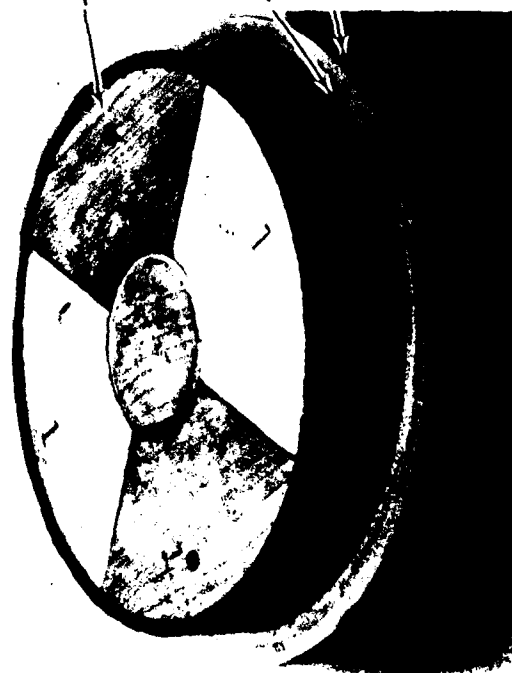
Figure 16. Inhibited Chem-Braze Bonding Assemblies

Ring Bonding Assembly

Engine Hardware Bonding Assembly

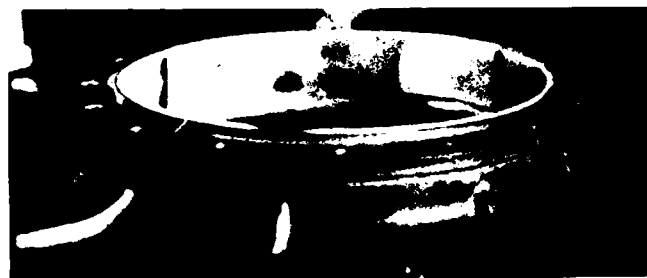
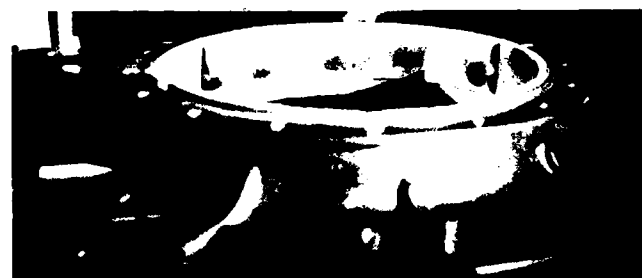
Figure 28. Diffuser Assembly NDI Analysis

Two indications of ICB defects were indicated by the pulse-echo NDI technique. However, close examination revealed that these indications matched perfectly with hardware raised platforms as shown in Figure 29. Discounting these reflections, pulse-echo ultrasonic NDI indicated that ICB seal attachments were completely free of disbond/void defects. Laser holography NDI showed that two seal segments were completely free of ICB attachment defects. The third seal segment contained a delamination that comprised less than 1% of the engine hardware's total seal attachment area. The size of this defect is considerably less than the commonly employed P&WA reject limit for gas path seal attachments.
